**MUNICIPAL SEPARATE STORM
SEWER SYSTEM (MS4)
COMPLIANCE AUDIT**

**STATE OF CALIFORNIA,
DEPARTMENT OF TRANSPORTATION**

**REPORT DATE:
February 26, 2010**

**EVALUATION CONDUCTED:
October 5–7, 13–14, and 21–22, 2009**

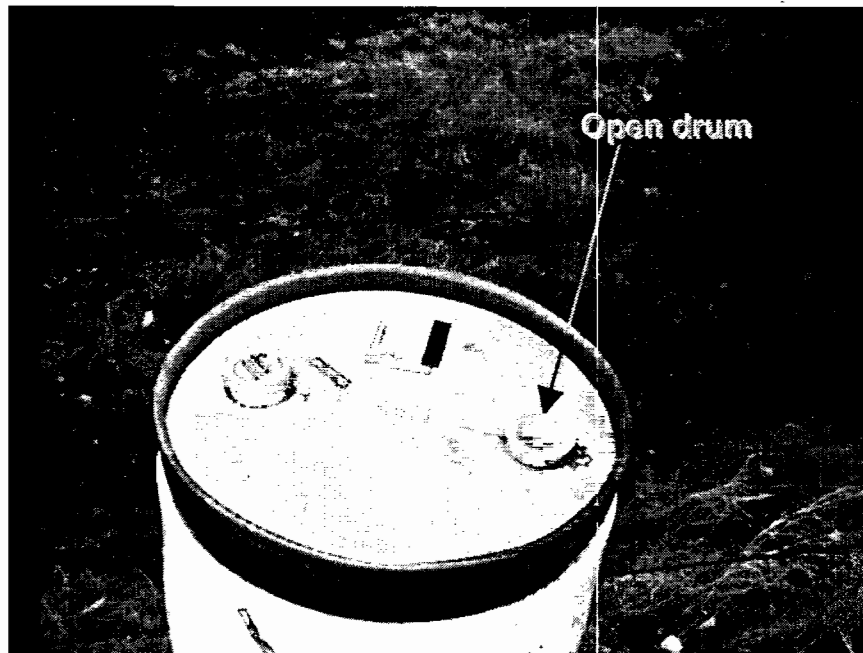
Photograph 3. District 2 Red Bluff Slab Project – Open drum of detergent along the highway storm water conveyance system. (Note: Drum appeared empty, possibly due to the missing bung)

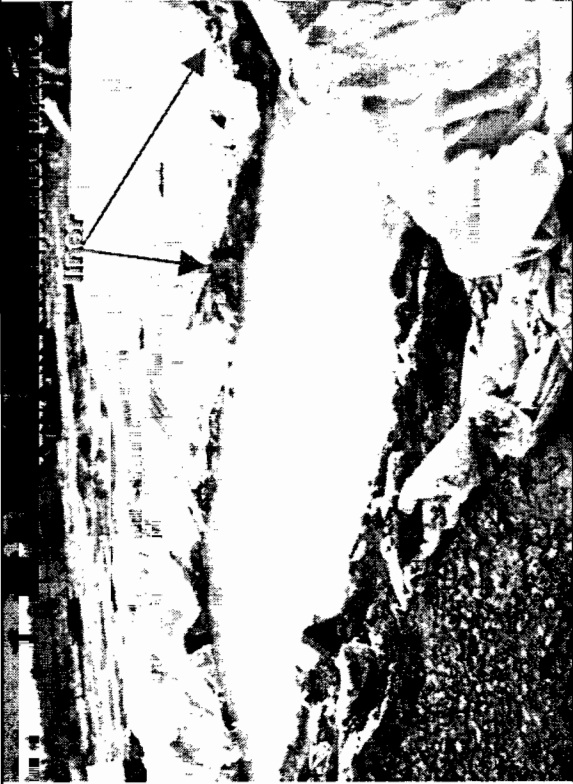
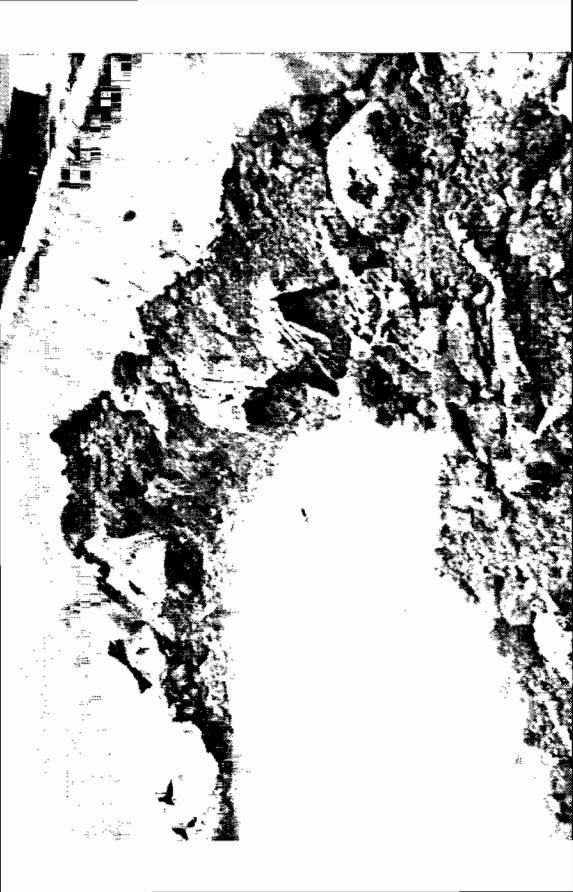
<p>Photograph 1 – Concrete washout unmaintained (e.g., torn and deteriorated plastic liner)</p> <p>Photograph 2 – Close-up view of unmaintained (e.g., torn and deteriorated) concrete washout plastic liner</p>

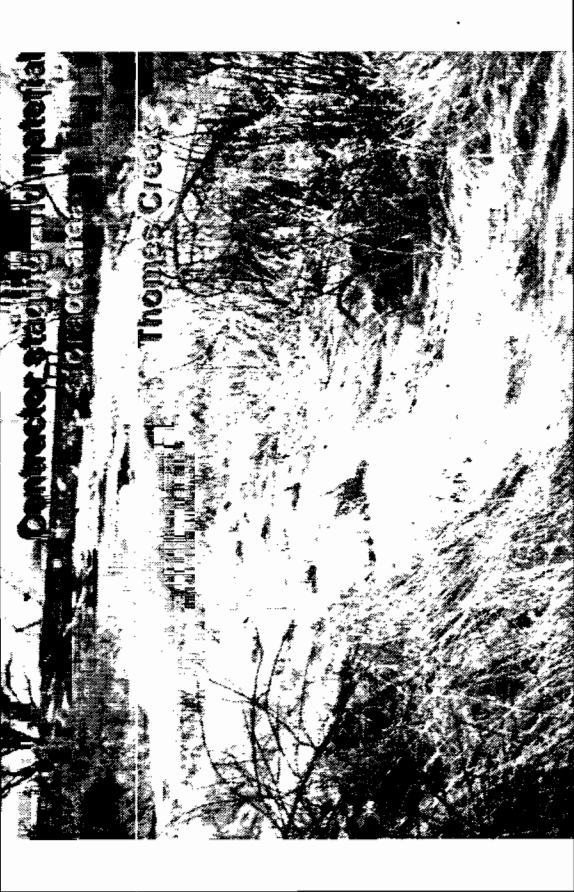
Prohibition A.1 of the Permit states that the “discharge of runoff from construction sites containing pollutants which have not been reduced using BAT for toxic pollutants and BCT for conventional pollutants to waters of the United States is prohibited.” Adequate BMPs or perimeter controls had not been implemented for the areas of disturbance associated with the contractor staging and material storage areas located up-gradient of Thomes Creek. For example, a concrete washout was improperly implemented and was lined with plastic that had been torn and badly deteriorated (see Appendix D, Site Visit No. 1, Photographs 1 and 2). In addition, uncontained concrete waste was observed on the ground surface directly adjacent to the concrete washout (see Appendix D, Site Visit No. 1, Photograph 3). The Caltrans District 2 Resident Engineer for the project stated that the concrete washout area had been present for a long time and was not identified in the project’s Storm Water Pollution Prevention Plan (SWPPP). Moreover, a visible discharge of sediment and/or other pollutants was observed leading from the contractor staging and material storage areas to Thomes Creek (see Appendix D, Site Visit No. 1, Photographs 4 through 7).

<p>Photograph 3 – Concrete waste on the ground surface directly adjacent to the concrete washout</p> <p>Photograph 4 – Evidence of the discharge of pollutants from the contractor staging and material storage areas</p>

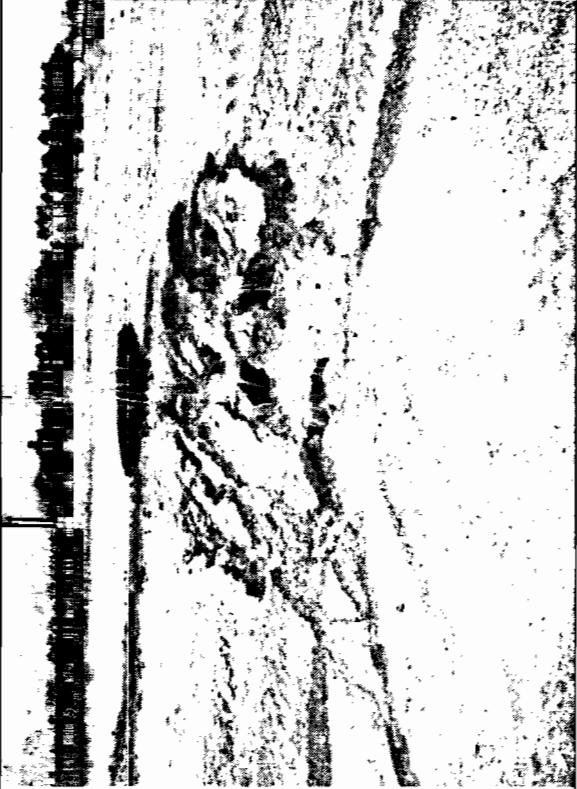
Photograph 3 – Sediment basin embankment slope erosion (e.g., gully formation) and failure

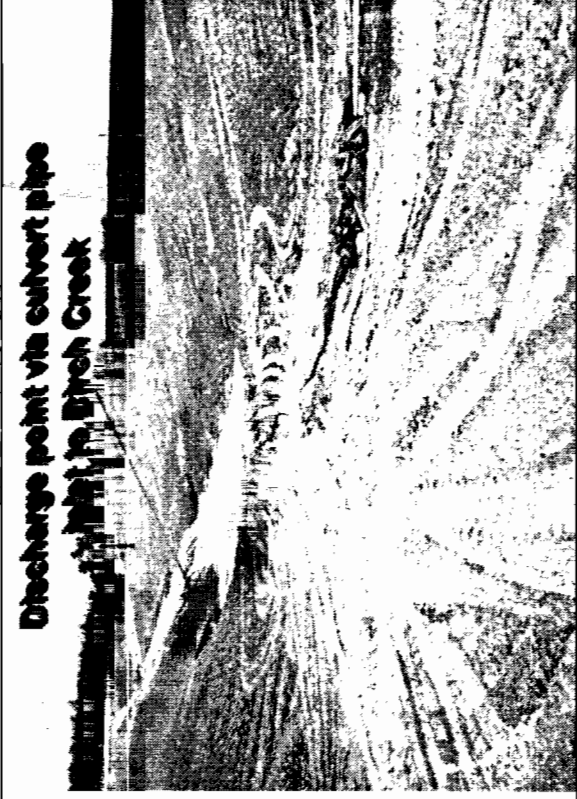
Photograph 4 – Adequate BMPs had not been implemented to prevent the discharge of sediment to the culvert inlet/drainage pipe leading to Birch Cr.

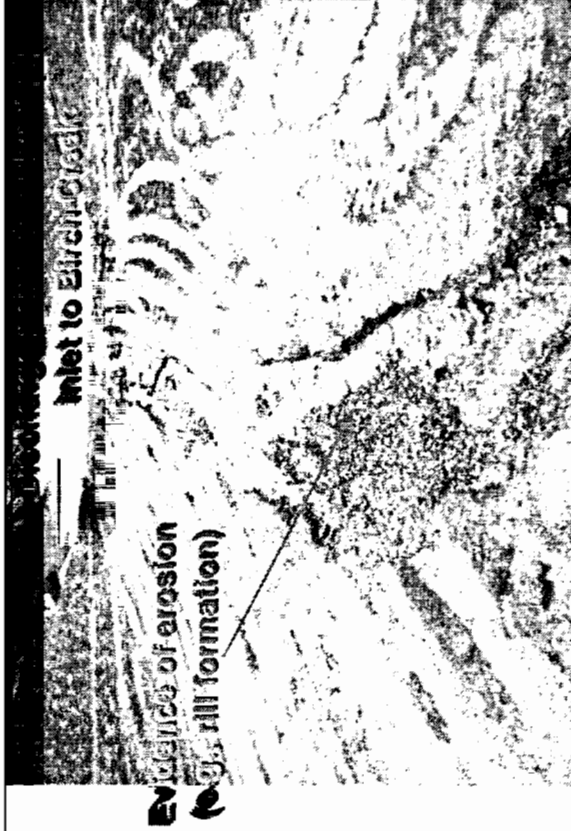
Photograph 5— Close-up of area in Photograph 4 depicting erosion (e.g., rill formation) and inadequate BMPs located adjacent to discharge point

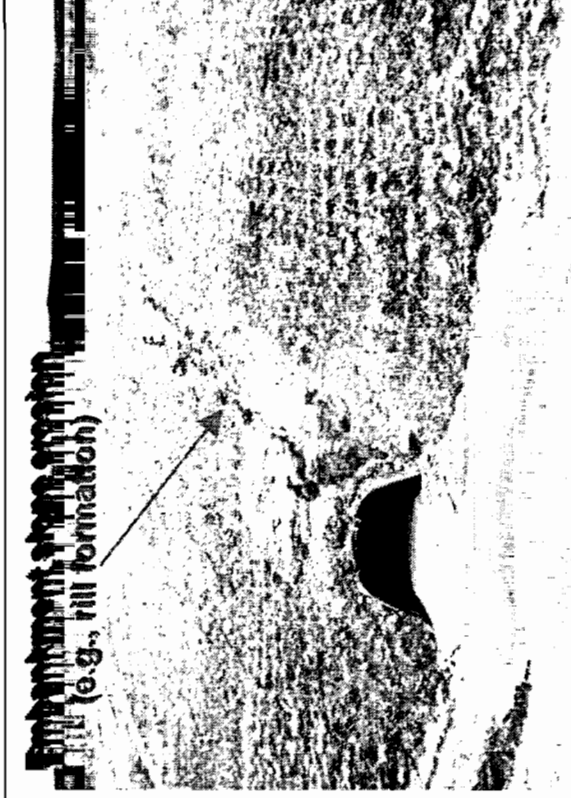
Photograph 6 – Embankment slope erosion (e.g., rill formation)

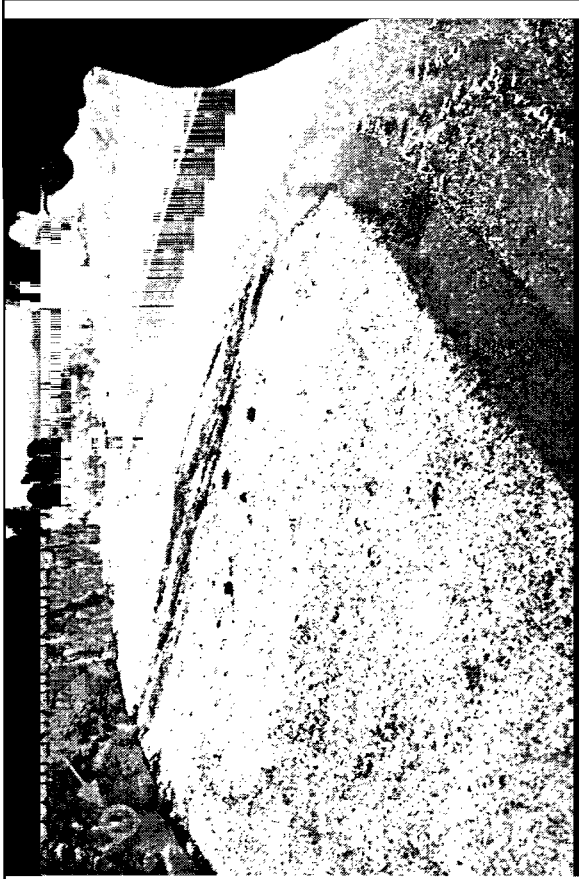
Photograph 2 – Run-off causing erosion along the highway shoulder

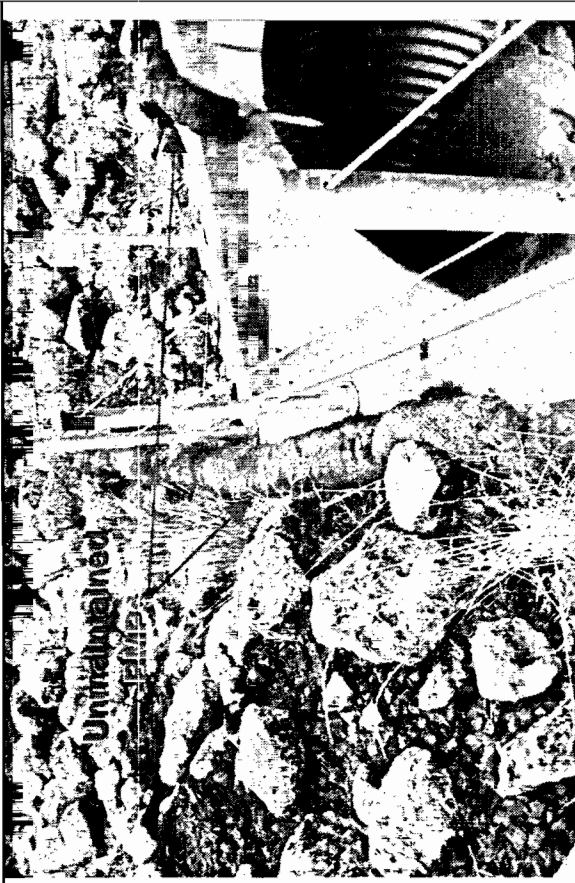
Photograph 8 – Inadequate straw wattle BMP maintenance at drainage pipe Inlet

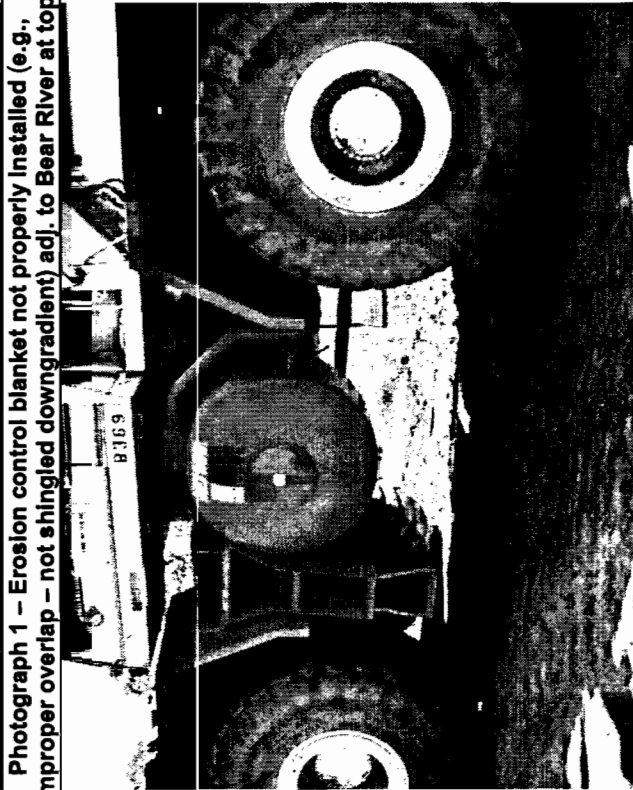
<p>Photograph 4 – Close-up view of petroleum product on ground surface</p>
<p>Photograph 3 – Equipment with petroleum product leaking onto ground surface (see Photograph 4 for close-up view).</p>

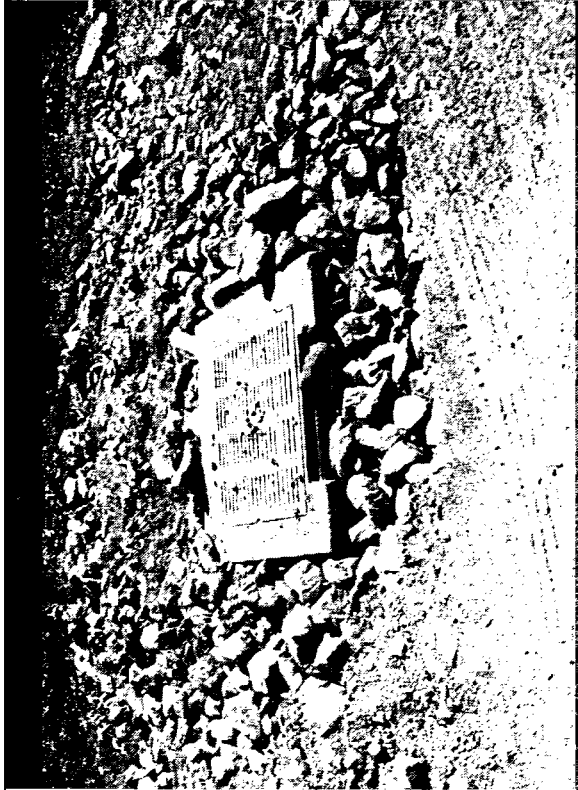
<p>Photograph 17 – Close-up of Photograph 16. Adequate inlet protection had not been implemented.</p>	<p>Photograph 18 – Inadequate materials handling and storage</p>

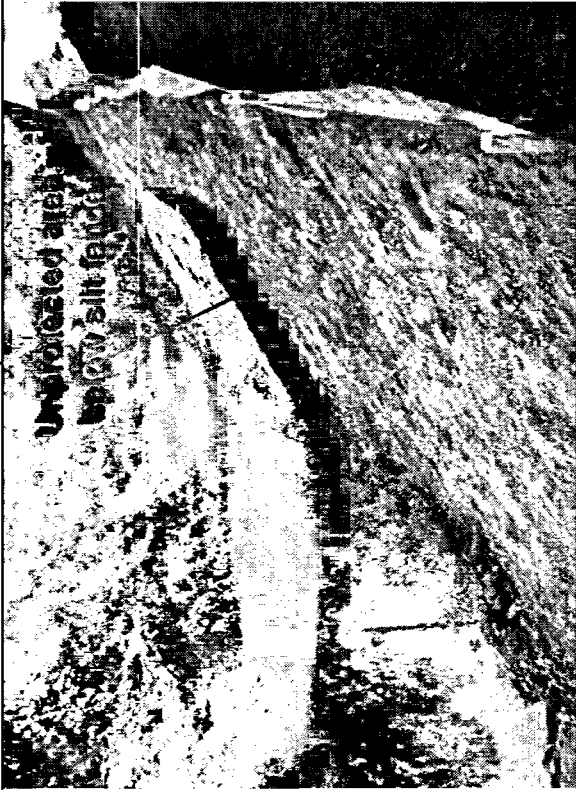
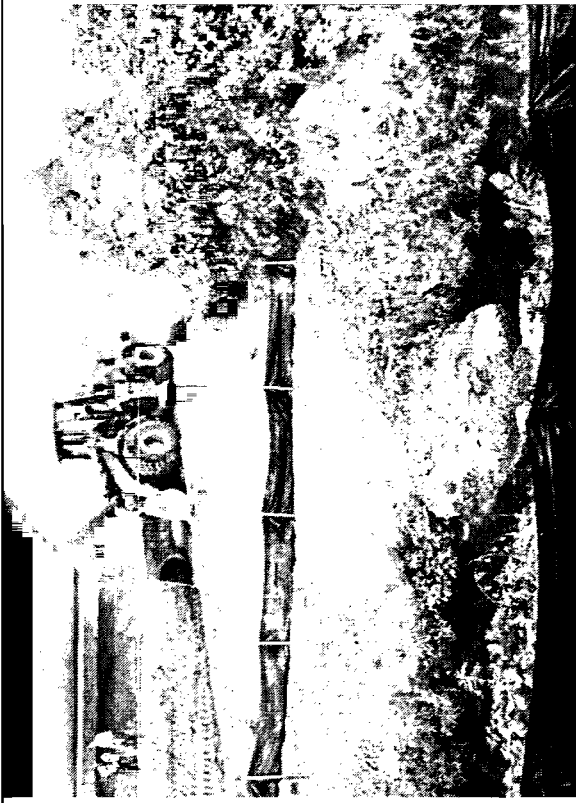
<p>Photograph 19 – Unstabilized slope area adjacent to Yankee Slough</p>	<p>Photograph 20 – Differing vantage point for Photograph 19</p>

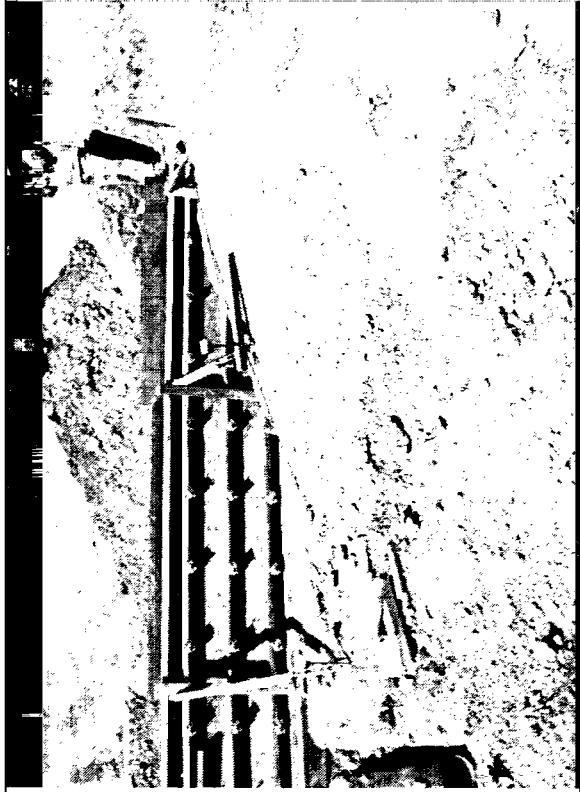
<p>Photograph 3 – Unconsolidated soil placed between the toe of the slope and the perimeter control BMPs along the waterway</p>	<p>Photograph 4 – No BMPs to control concentrated flow off of the plastic and across the unconsolidated material at the toe of the slope</p>

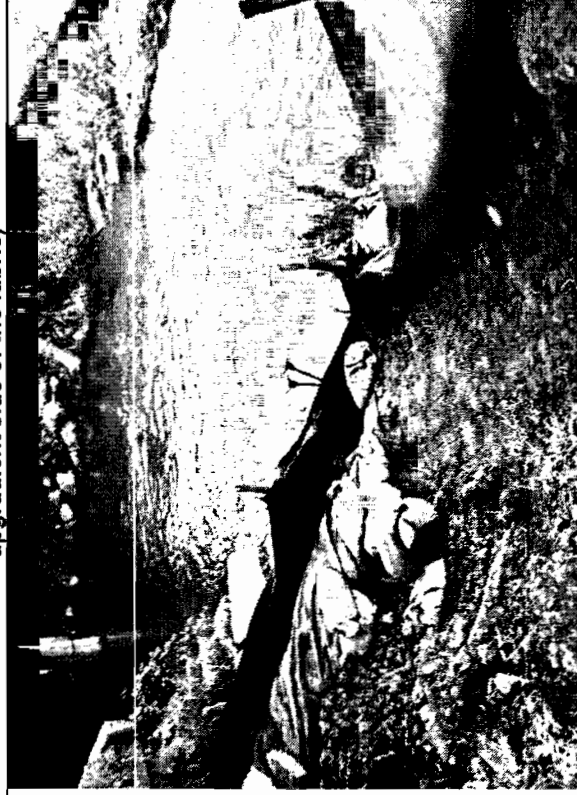
Photograph 12 – Silt Fence BMP not adequately maintained (e.g., down in areas; deteriorated) adjacent to Auburn Ravine

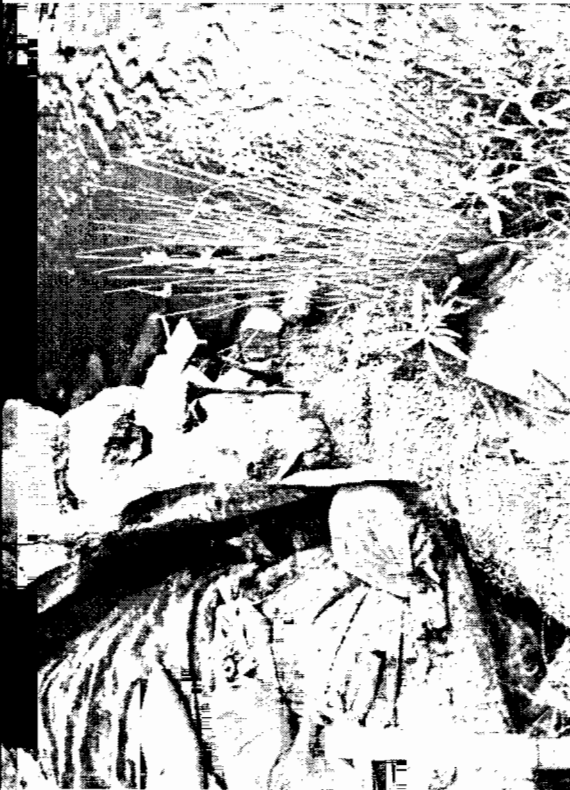
<p>Photograph 13 – Differing vantage point from Photograph 12 depicting unmaintained Silt Fence BMP adjacent to Auburn Ravine</p>

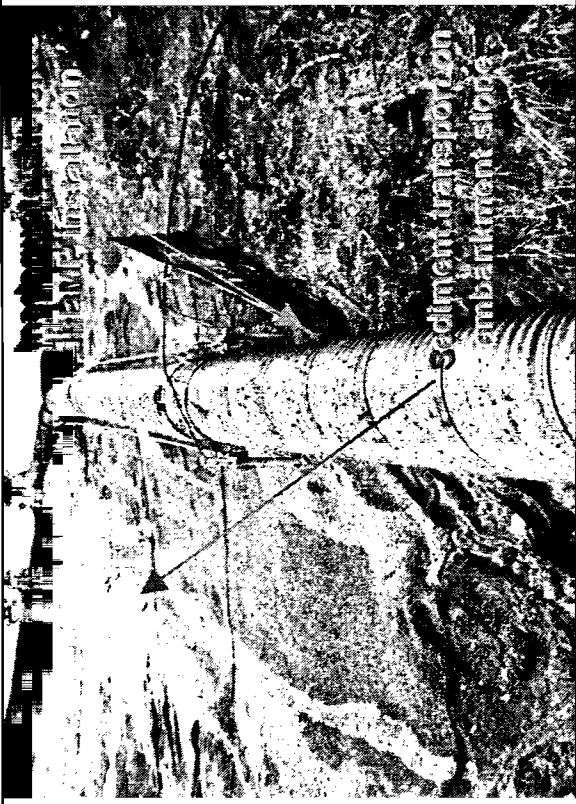
<p>Sediment transport on embankment slope</p>	<p>Photograph 14 – Evidence of sediment transport on the embankment slope of the field constructed sediment basin No. 2. Inadequate silt fence BMP installation under culvert pipe</p>

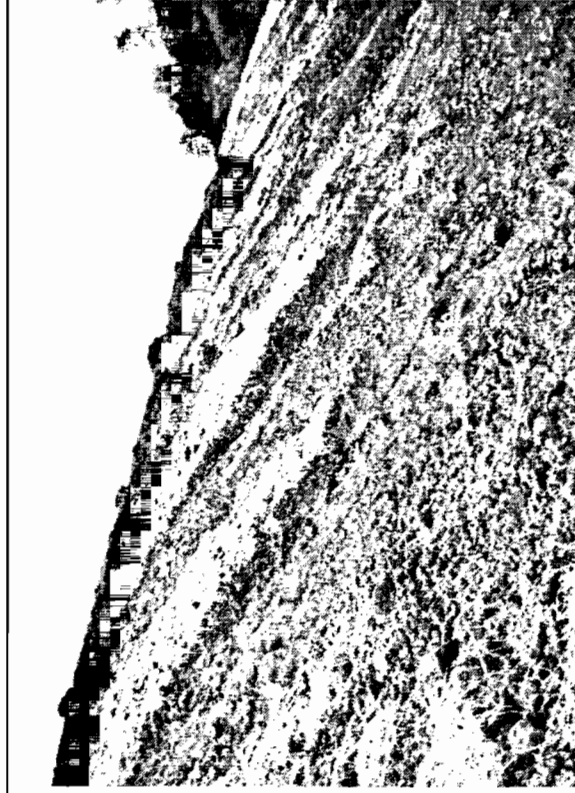
Photograph 1 – Evidence of erosion and slope failure on disturbed slope areas draining to Crystal Creek on the south side of State Highway 299

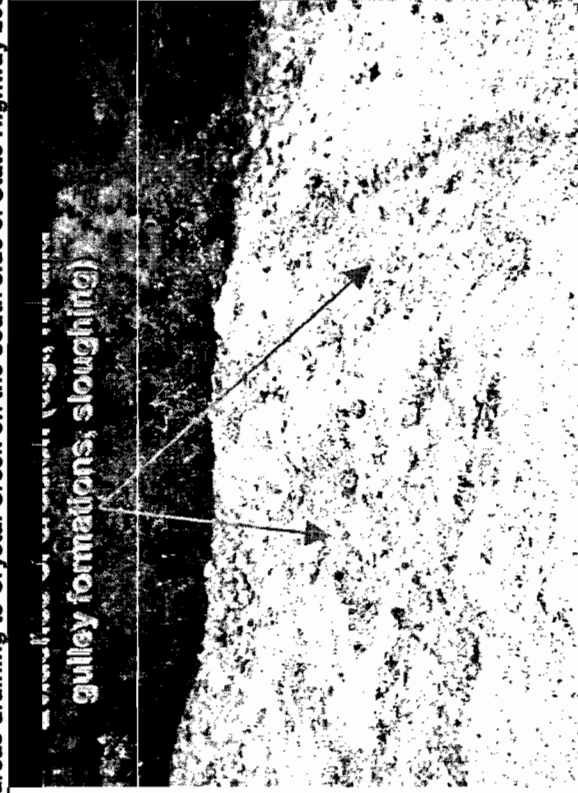
Photograph 3 – Evidence of erosion (e.g., rill and gully formation) and sediment transport from the disturbed slope failure

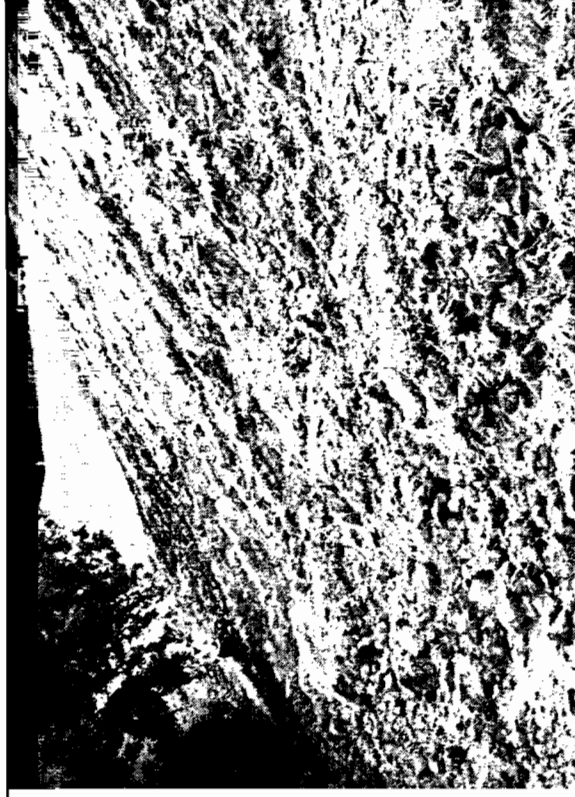
Photograph 2 – Evidence of erosion and slope failure on disturbed slope areas draining to Crystal Creek on the south side of State Highway 299

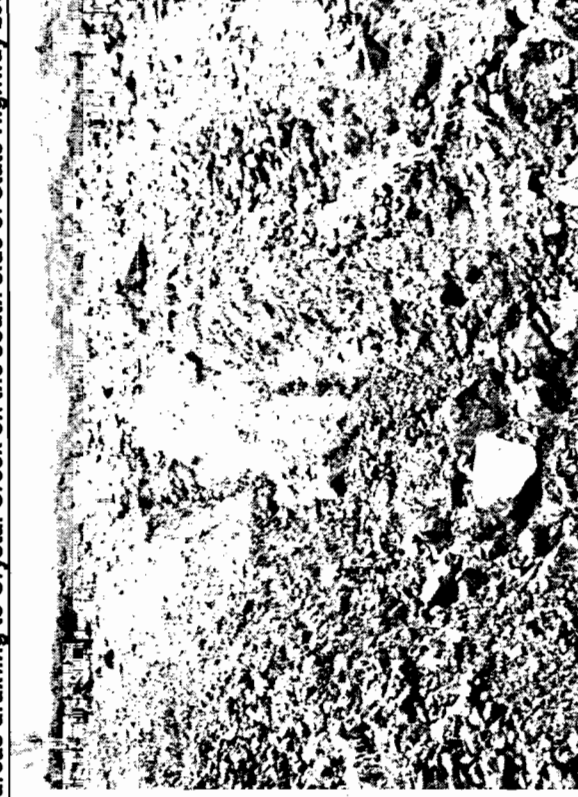
Photograph 4 – Visible evidence of erosion (e.g., rill and gully formation) on the disturbed slope area draining to Crystal Creek

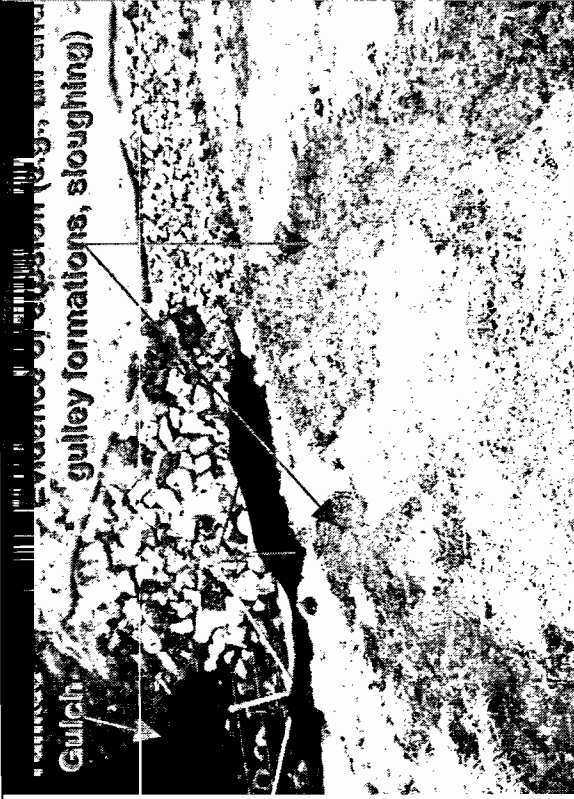
<p data-bbox="902 222 935 974">Evidence of erosion (e.g., rill and gulley formation) Gulch</p>	Photograph 8 – Evidence of erosion (e.g., rill and gulley formation) and sediment transport from the disturbed slope failure

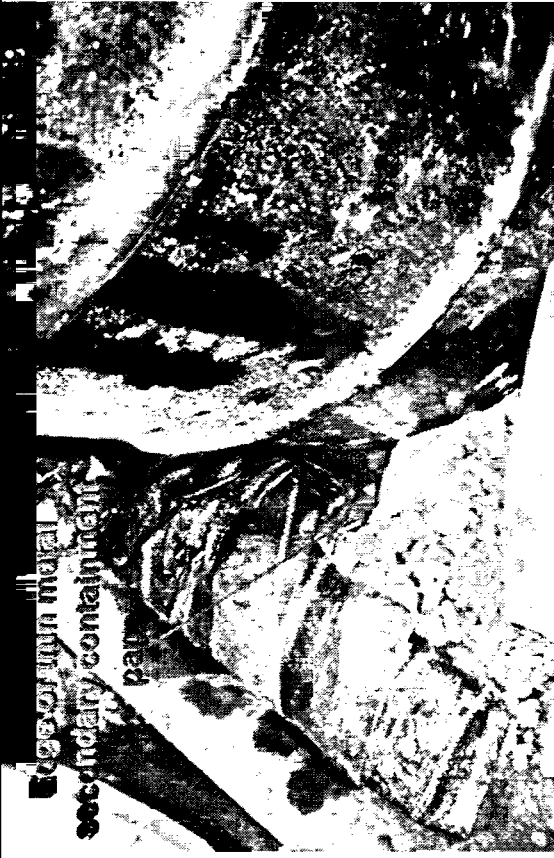
<p>Close-up view of damaged secondary containment pan underneath 55-gallon drum</p>

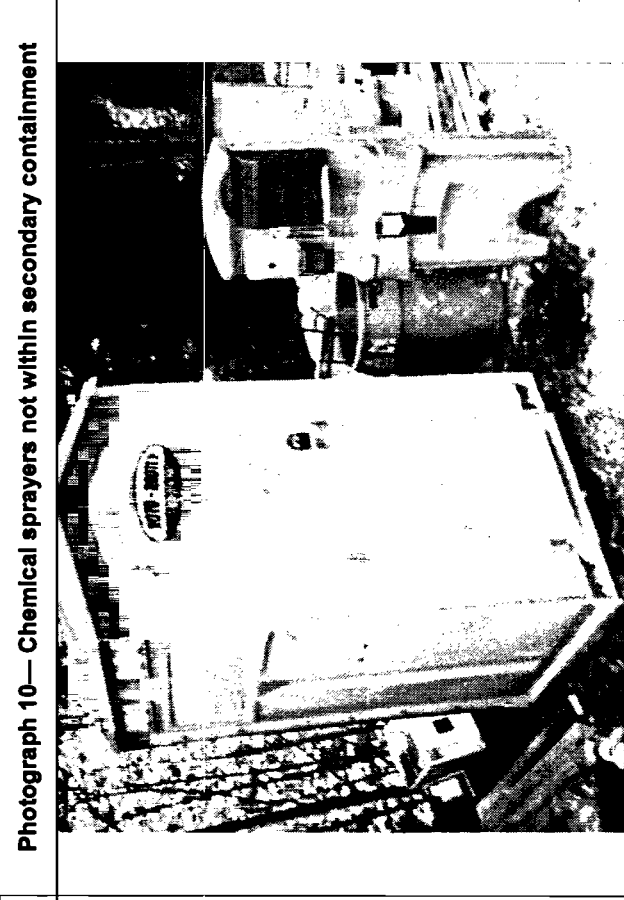
<p>Chemical sprayers not within secondary containment</p>

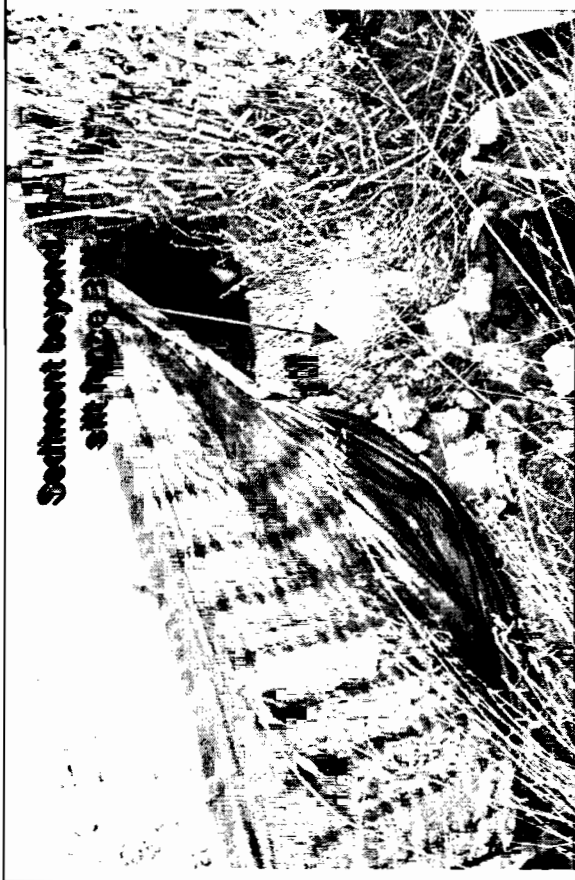
Photograph 5— Failure of first tier of silt fence shown in Photograph 4

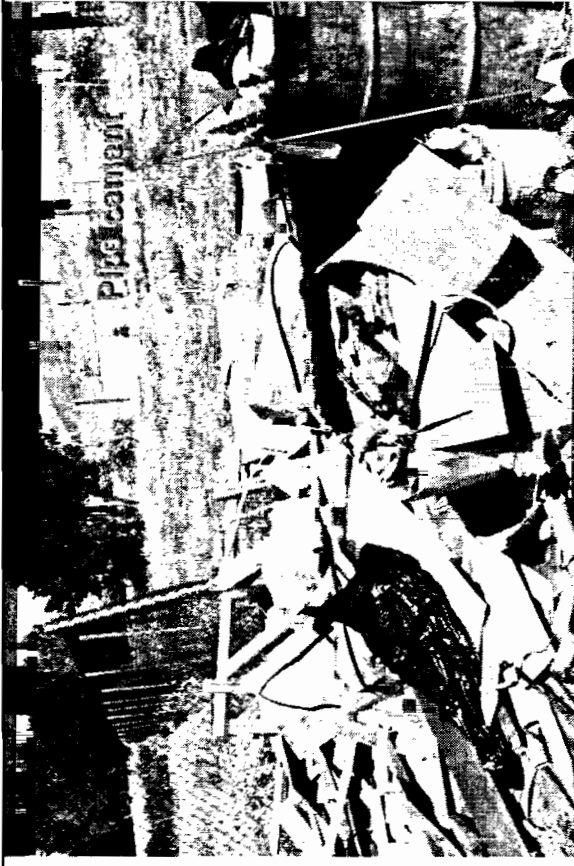
Photograph 1 – Construction wastes and chemicals improperly disposed

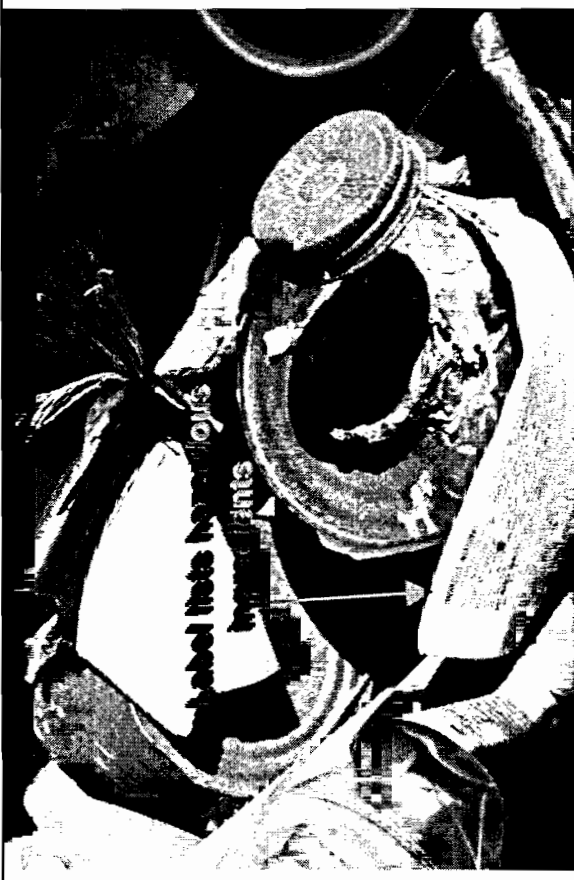
Photograph 2 – Close-up view showing open containers of pipe cement

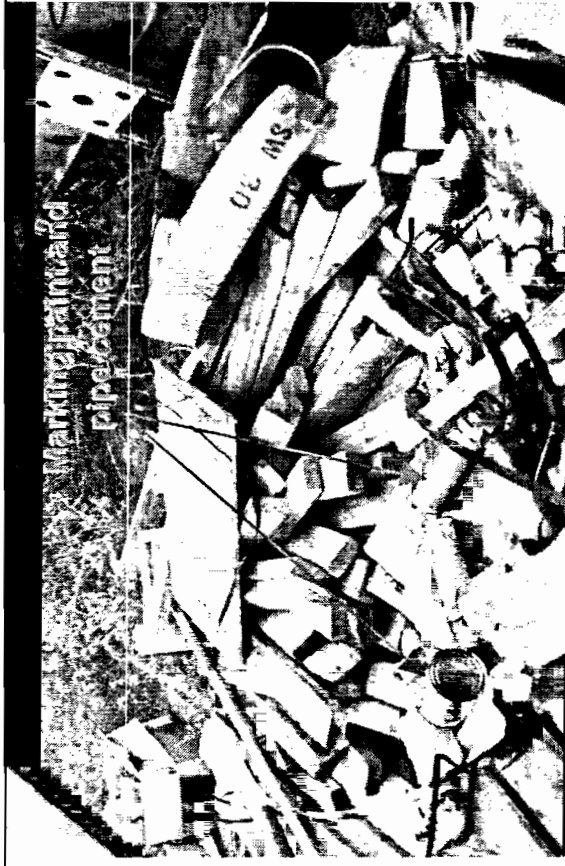
Photograph 3 – Construction wastes and chemicals improperly disposed

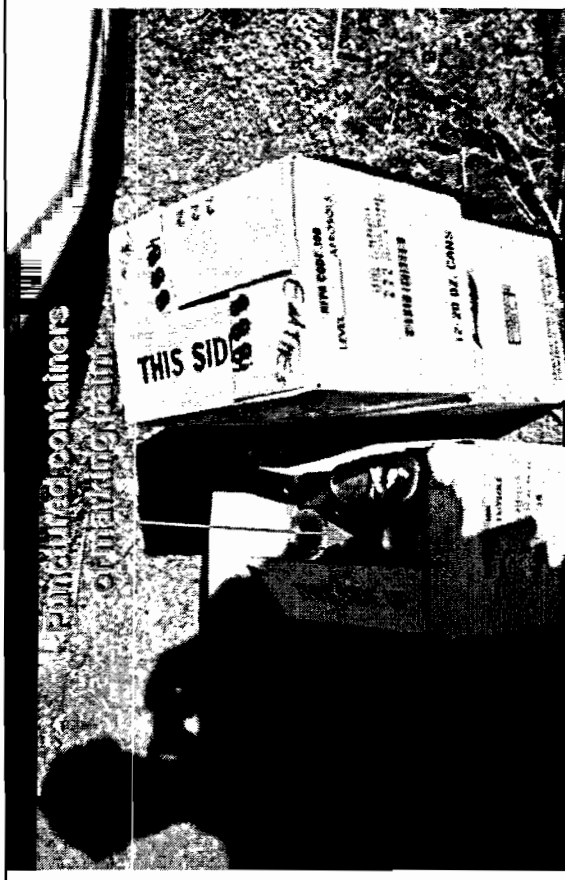
Photograph 4 – Construction wastes and chemicals improperly disposed

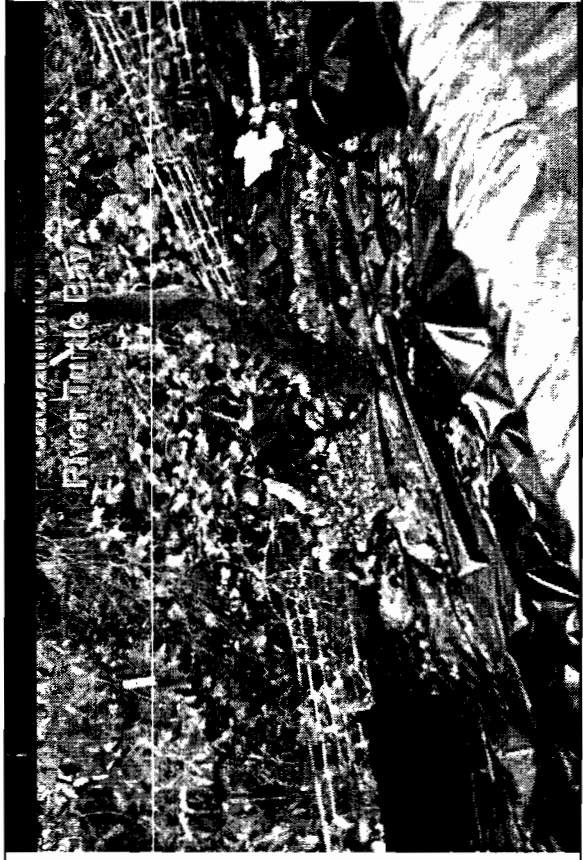
Photograph 3 – View of deteriorated slope stabilization BMP and collapsed silt fence in Photograph 2

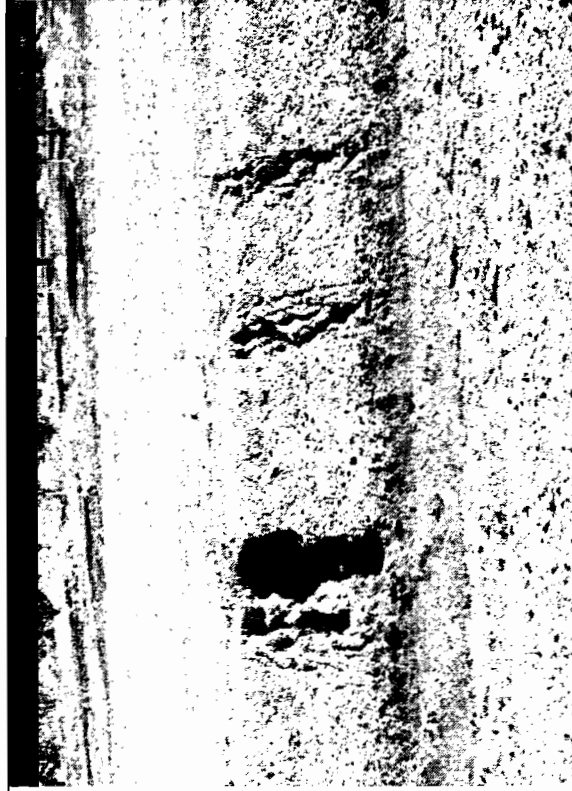
Photograph 17 – Evidence of previous erosion (e.g., rill/gully formation) was observed on the adjacent roadway drainage swale slopes (West side).

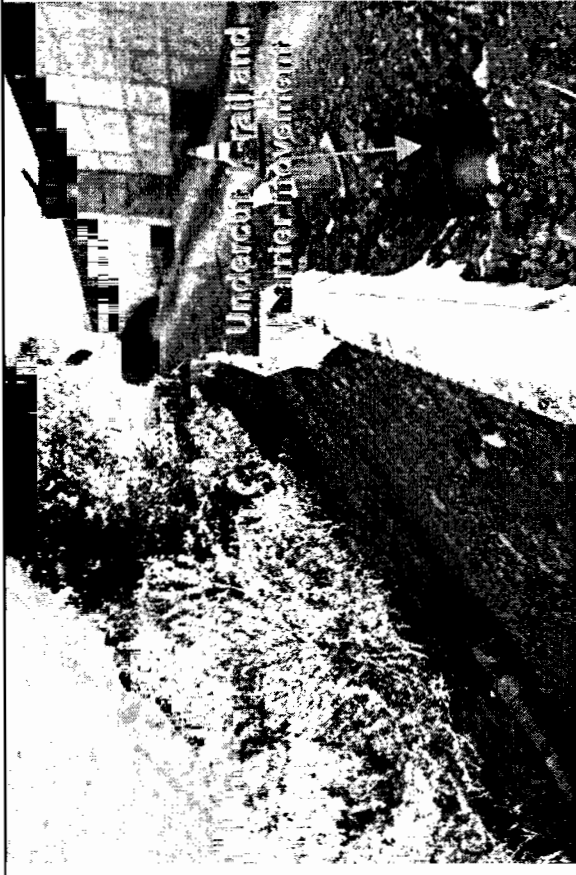
Photograph 2 – Failed fill slope along access road

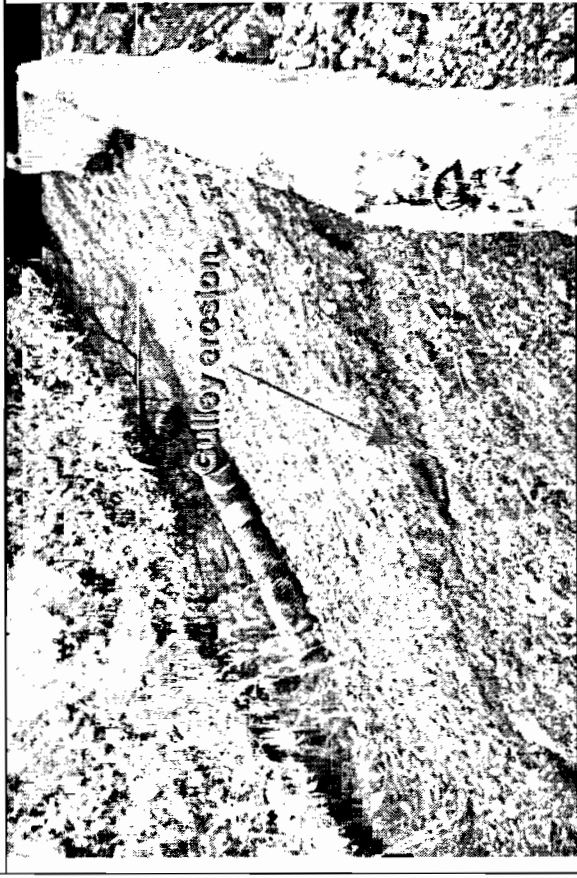
Photograph 3 – Slope erosion below undercut K-rail shown in Photograph 2

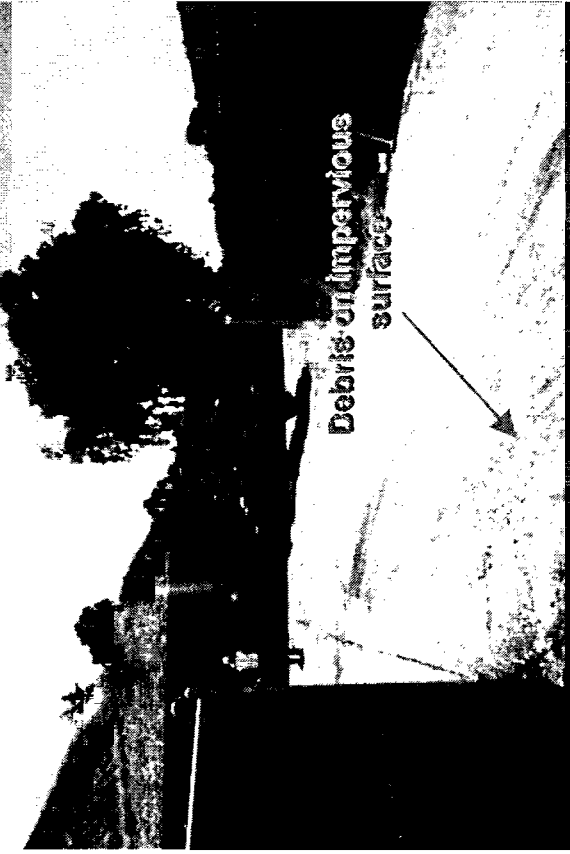
<p>Photograph 1 – Entrance to temporary storage site. (Note: Impervious roadway entrance and tracking of debris)</p>

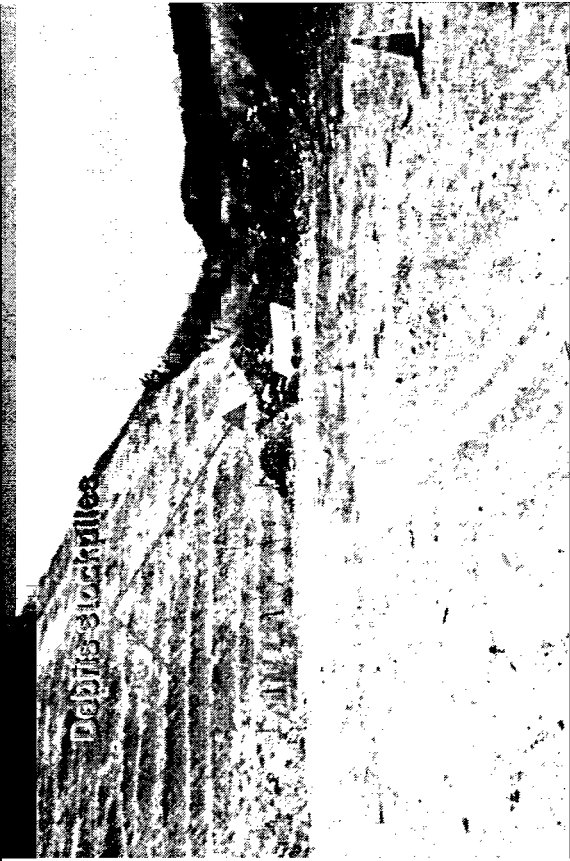
<p>Photograph 3 – Close-up view of debris stockpile from road sweeping and other road cleaning activity</p>	<p>Photograph 4 – Close-up view of debris in stockpile pictured in Photograph 3. The metal cans appeared to contain a liquid milk substance.</p>

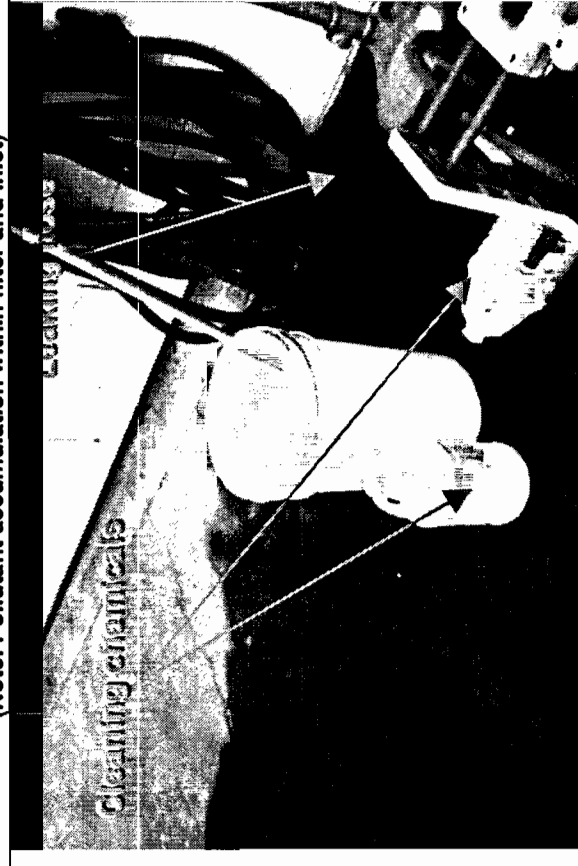
In addition, two containers of a cleaning agent were improperly stored adjacent to a concrete drainage swale and a leaking hose along the eastern side of the facility (see Appendix E, Site Visit No. 21, Photograph 11). The containers were not stored within secondary containment, and as a result there was a potential for the contribution of wash water and pollutants to storm water runoff, and subsequently to a downgradient storm drain inlet (see Appendix E, Site Visit No. 21, Photograph 12).

Photograph 11— Cleaning/washing chemicals stored on impervious ground surface adjacent to leaking hose

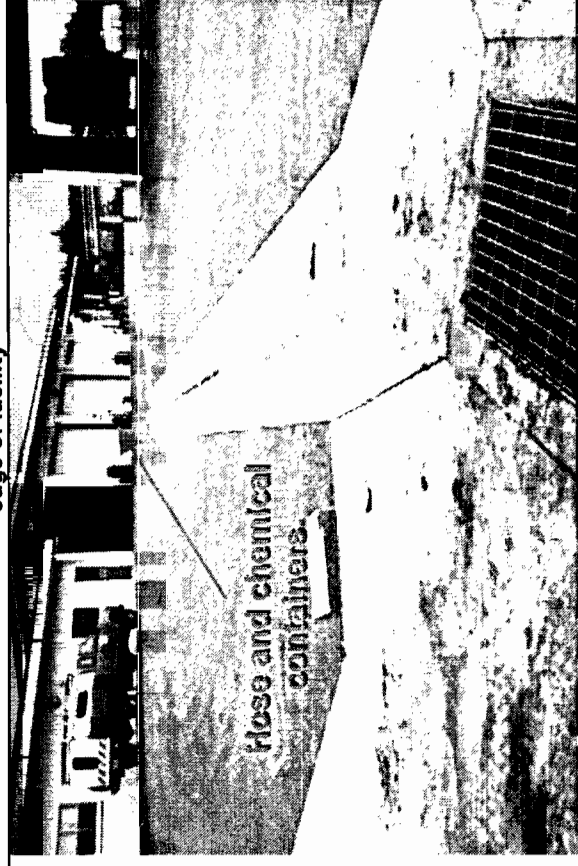
Photograph 12— View from down-gradient storm drain inlet to location of hose and chemical containers pictured in Photograph 11

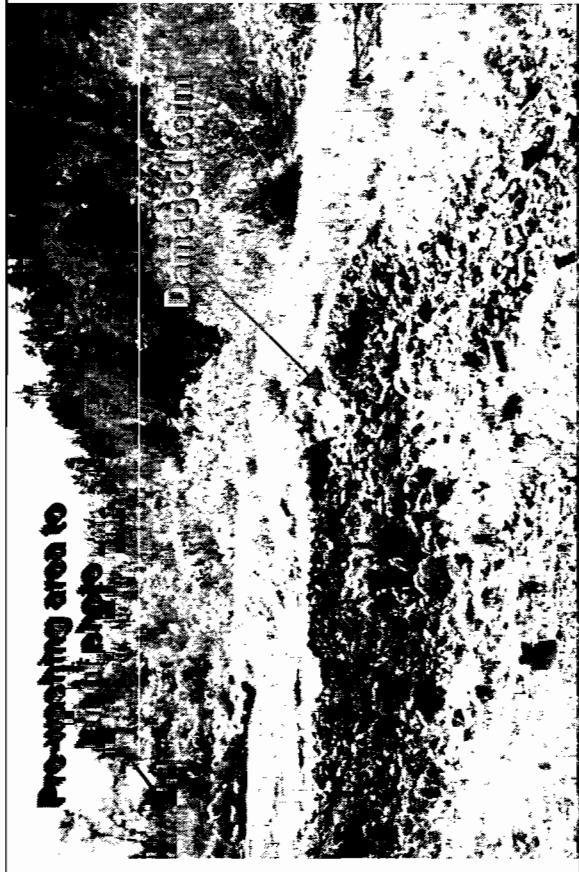
Photograph 7— Damaged berm shown in Photograph 6

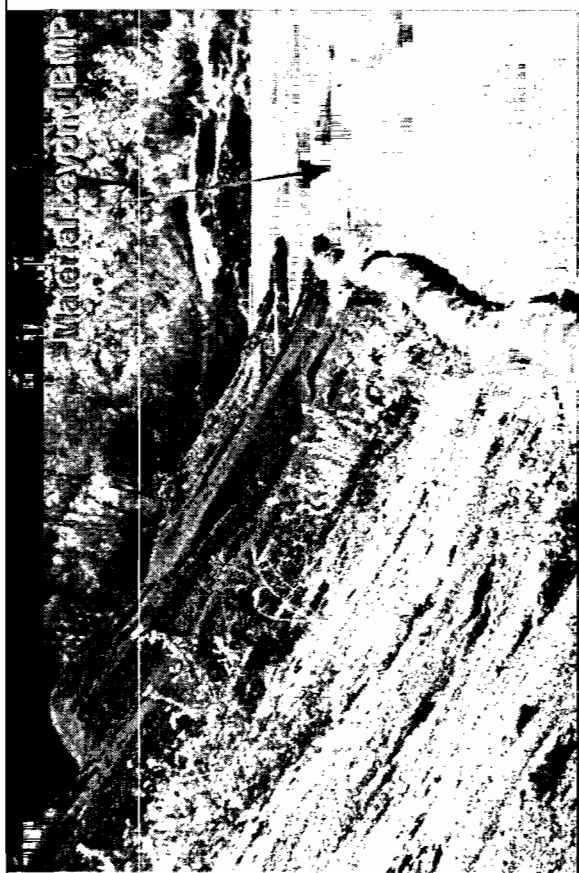
Photograph 8 – Inappropriate application of wattles on impervious surface

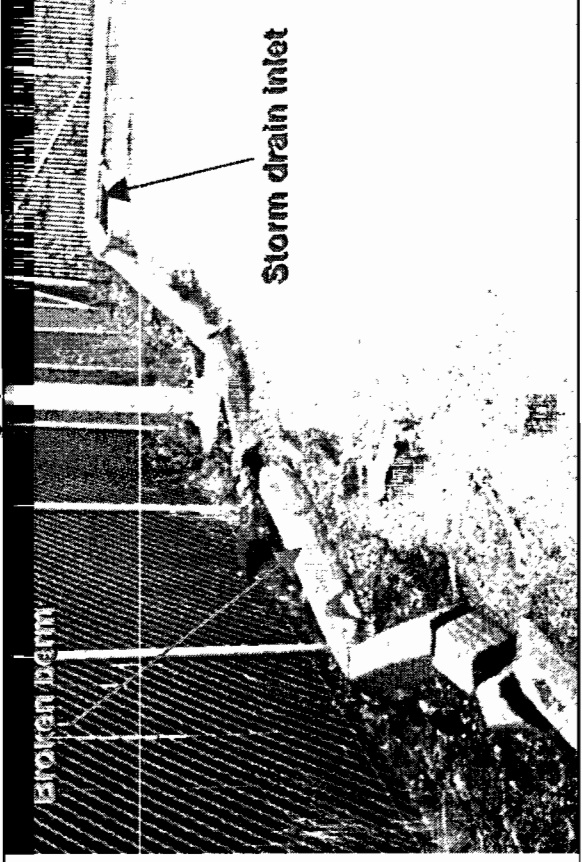
Photograph 4 – Broken berm along northern perimeter of facility
(Note: Accumulation of roadway abrasives adjacent to berm)
